WHAT WENT WRONG?

Case Study: Concrete Cantilever Carport

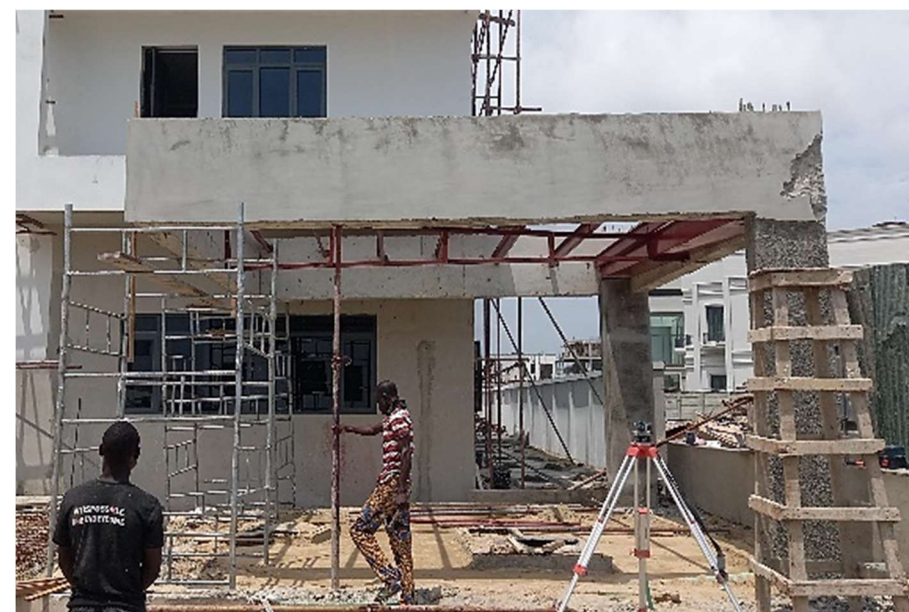
Figure 4: Car port after de-propping

Day 28 -post casting of the cantilever beams arrived, and the workmen observed an overt stiffness in the props beneath the beams as though they were still very active in the load sharing arrangement.

On complete prop removal, the displacement of the cantilevers was monitored closely and observed to progress beyond projections. A crack pattern was likewise observed at the beam-column intersection. See Figure 5 for sketch of crack observed.
