WHAT WENT WRONG?

Case Study: Concrete Cantilever Carport

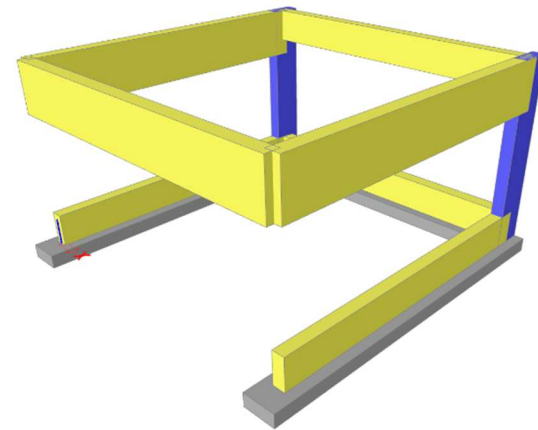
Figure 1: The Carport Frame + Foundation.

The concrete structure rests on 600mm wide strip foundation (Inverted Tees). The frame consisted of 2 Nos 900 x 230 -6m long cantilever beams (30mm camber), 5.77m apart each anchored into 600 x 230 columns and restrained at their start & end.
